PTO ROD ROTATION REPAIR

Service Bulletin 2-24

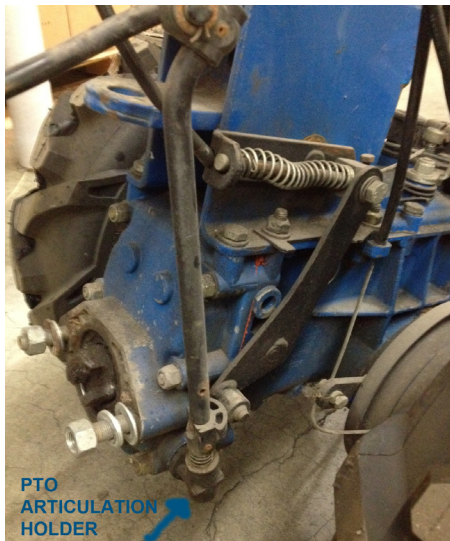
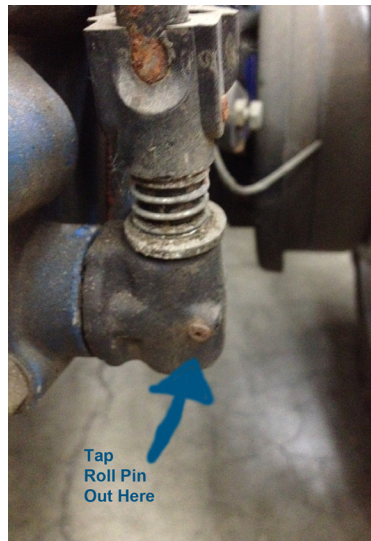
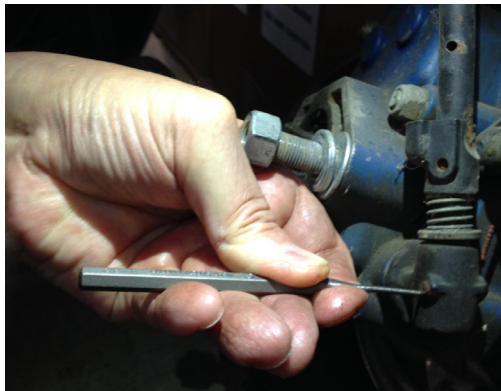
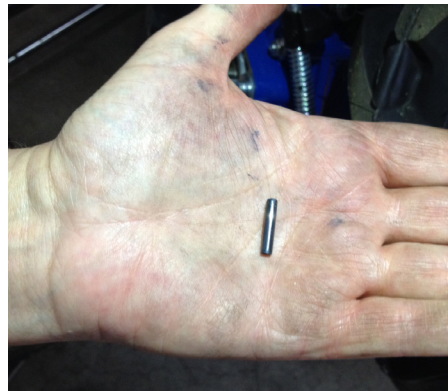
One common problem with the PTO engagement lever on all BCS tractor models is that the articulation point at the base of the vertical rod can rust and will not rotate. This prevents engagement of the PTO.

1. Rotate handlebars and shifting lever into front-mount mode, or mode opposite from stuck position.
2. The PTO rod will not rotate due to rust buildup in pivot point.
3. Tap roll pin out from PTO Articulation Holder using punch and punch holder. Since the joint is rusted, this will not be easy. Use patience, penetrating oil, and maybe a little heat from a hand held propane torch, but go easy, there is an oil seal close by.
