SERVICE	2-15
	INFORMATION

Subject: Gear Selection Decal for Models 830 - 850

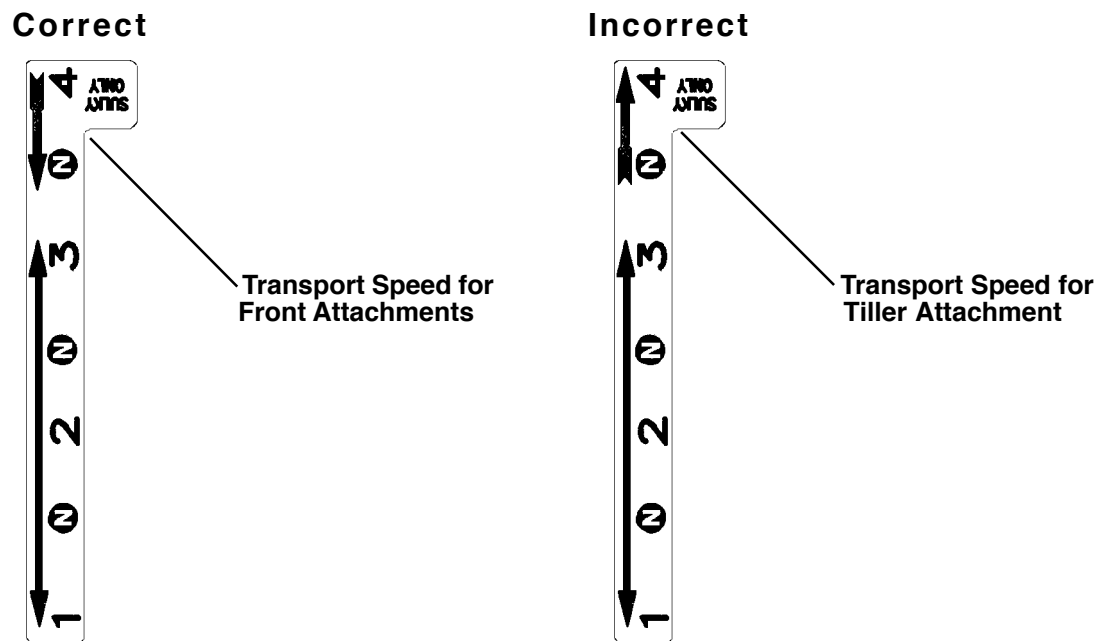
Illustration 1

It has come to our attention that the gear selection decal for the model 830 - 850 may be incorrect on some of these tractors. This decal should show that the transport gear (4th Gear) be used only with front mount attachments. The incorrect decal shows the transport gear as being used with the tiller attachment. The decal that should be on these tractors can be identified by checking the decal on the unit to the decals pictured below.

We are requesting that all the units be checked for the incorrect decal and gap adjustment. If a tractor has the incorrect decal, the correct decal (p/n 580.57706) should be ordered. This decal will be sent as a no charge order to correct this situation.

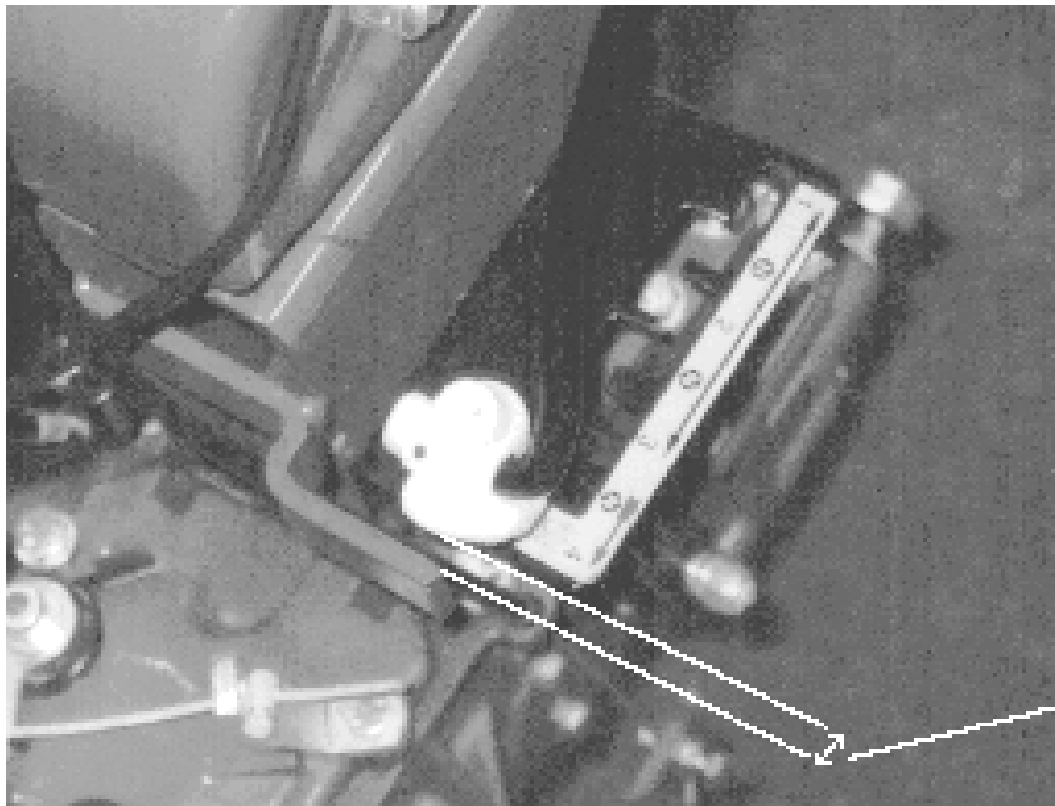
Illustration 2

The transport gear lockout is to insure that the unit will not be allowed to shift into the transport gear while the handlebars are in the tilling mode. Some of the model 830 & 850 units may have too large a gap between the articulator and the stop bracket. The correct spacing for the lockout should be 2mm-6mm between the articulator and the stop bracket when the unit is set up as a tiller and the gear selector is in the neutral between 3rd and 4th gear. (see illustration 2) This will insure that this unit will not be allowed to shift into the transport gear while tilling.

A 2mm to 6mm Gap should exist between the articulator and stop bracket

To adjust the gap between the articulator and stop bracket, strike the stop bracket with a hammer and bend into position.
